World Trade Center Hot Spots

20 September 2009(created 31 January 2008) references

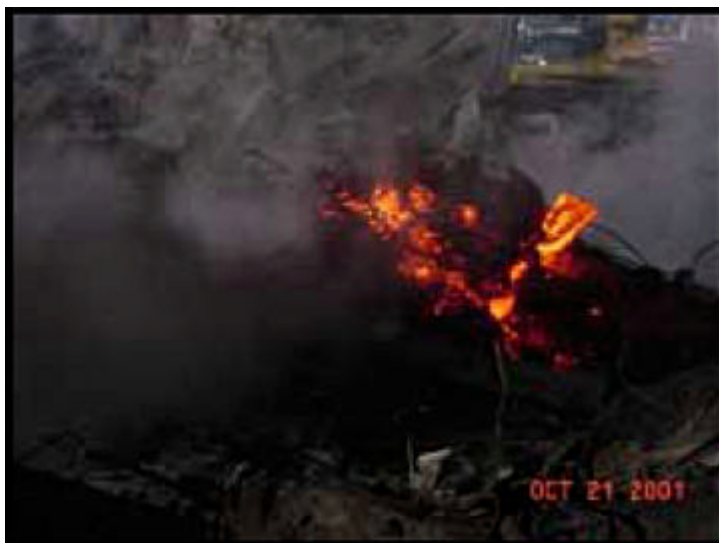
Red Hot Debris. The removal of debris from the collapsed areas requires the safe lifting and maneuvering of very heavy steel beams, often twisted and tangled from the force of the collapse. Some beams pulled from the wreckage are still red hot more than 7 weeks after the attack, and it is suspected that

temperatures beneath the debris pile are well in excess of 1,000°F. [liro.com](#)

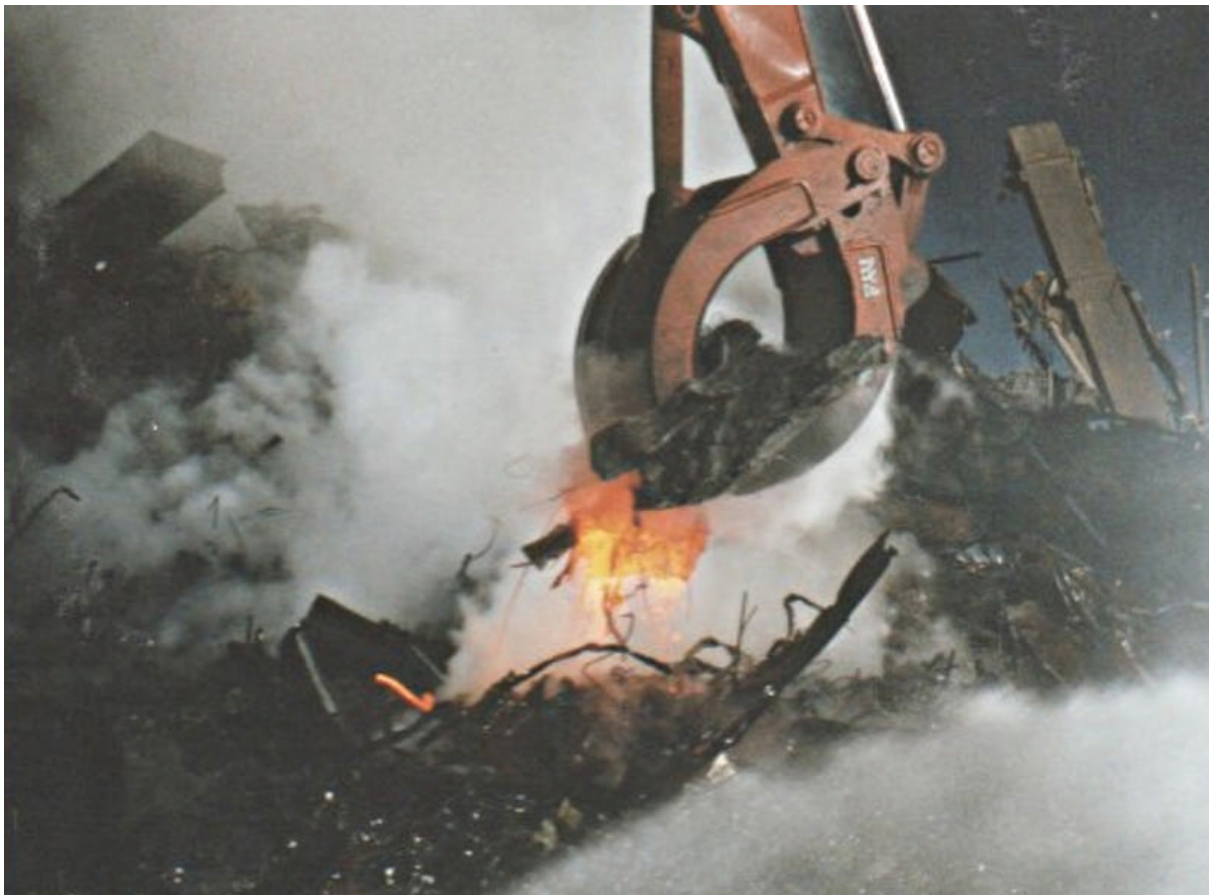
"2 weeks later, molten steel" North Tower, 27 September 2001. ([Frank Silecchia](#)).

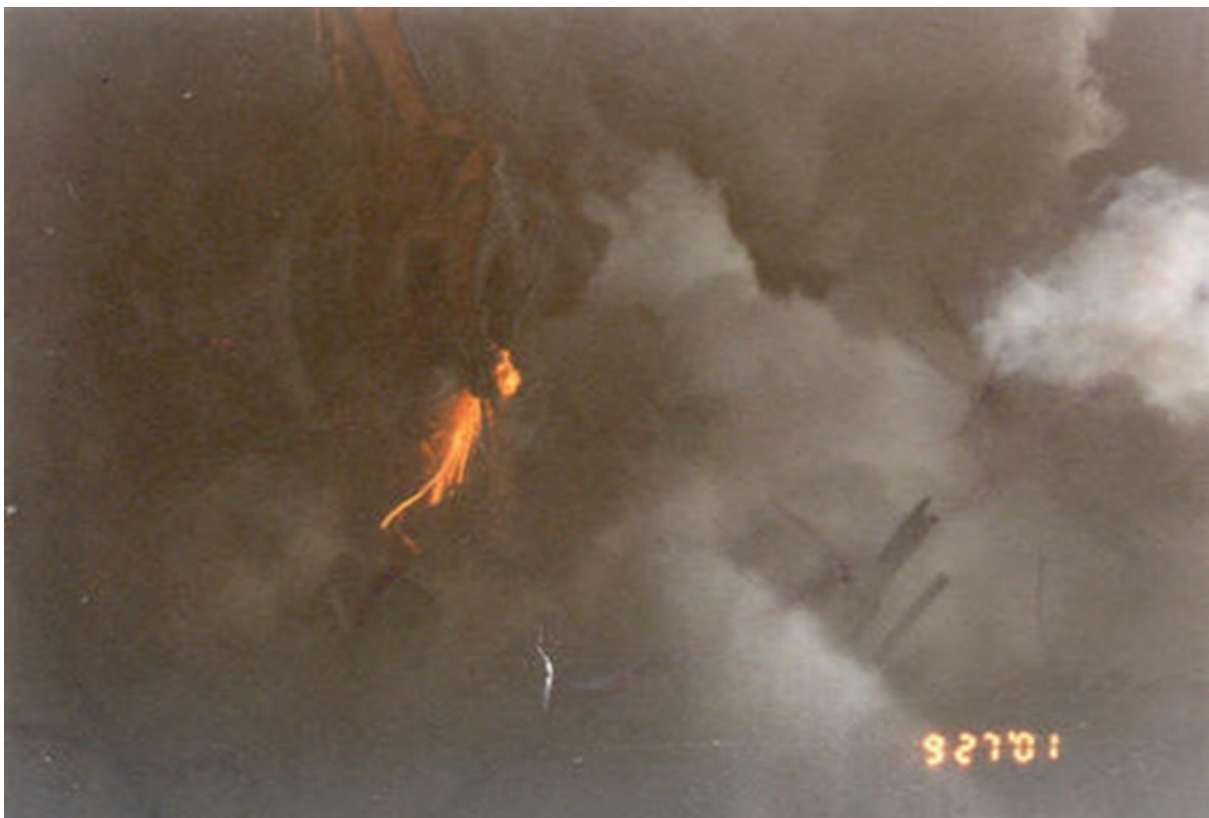
Red hot metal, 27 September 2001. Picture by Franck Sillechia, ironworker. ([source](#))

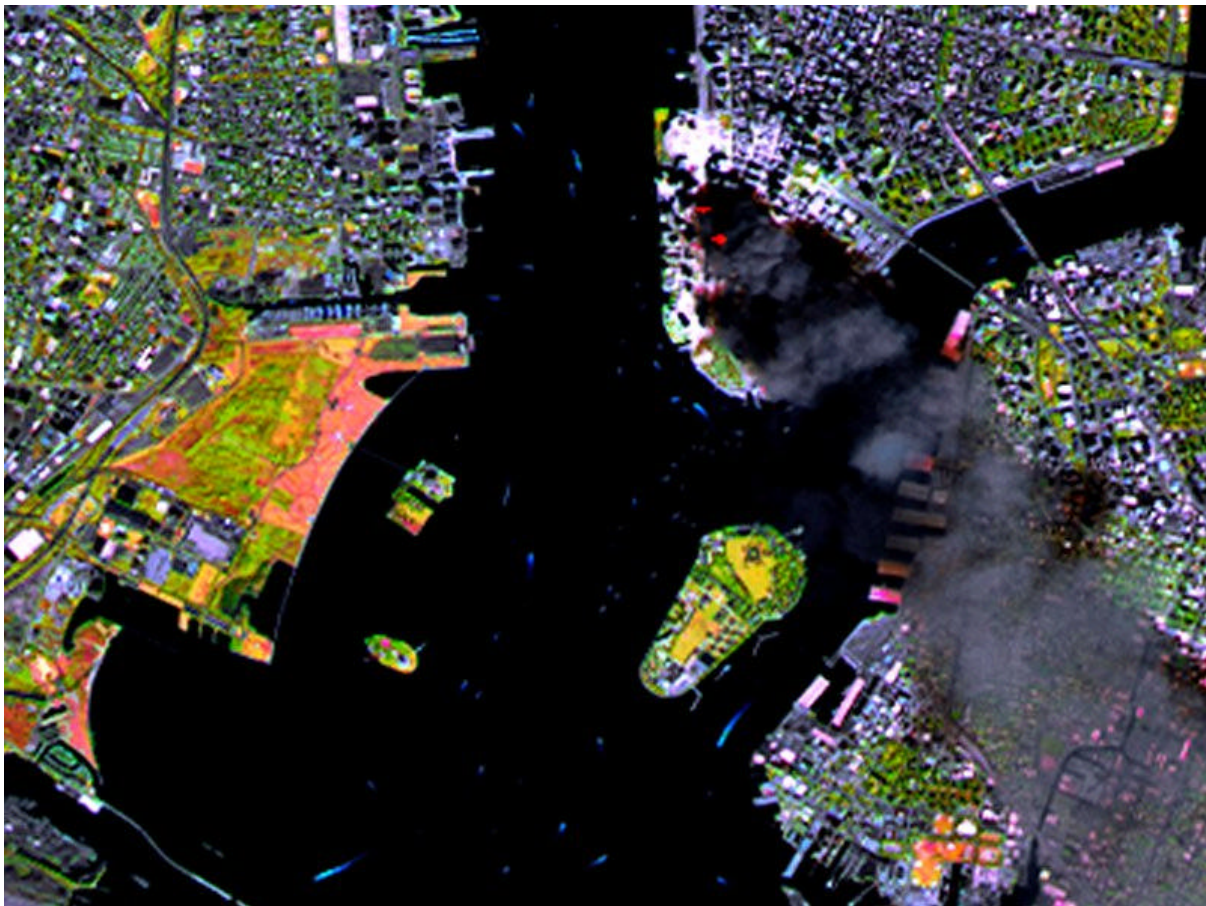
SPOT satellite image of Manhattan, using the **HRVIR** (High Resolution Visible Infra Red instrument) on **SPOT 4**, acquired on September 11 at 11:55 AM EST, 3 hours after two planes crashed into the World Trade Center. The colors result from the use of infrared bands to identify the actual fire hot spots (see red spots near the base of the smoke plume). The SPOT satellites orbit at an altitude of 822 km. (c) CNES/SPOT Image 2001 [full image](#)

Resolution: 20 meters; Acquisition time: 09/11/01 11:55 AM EDT; Orbital altitude: 822 km

Band combination: Not specified, but presumed to be:

R 0.79 - 0.89um

G 0.61 - 0.68um

B 0.50 - 0.59um

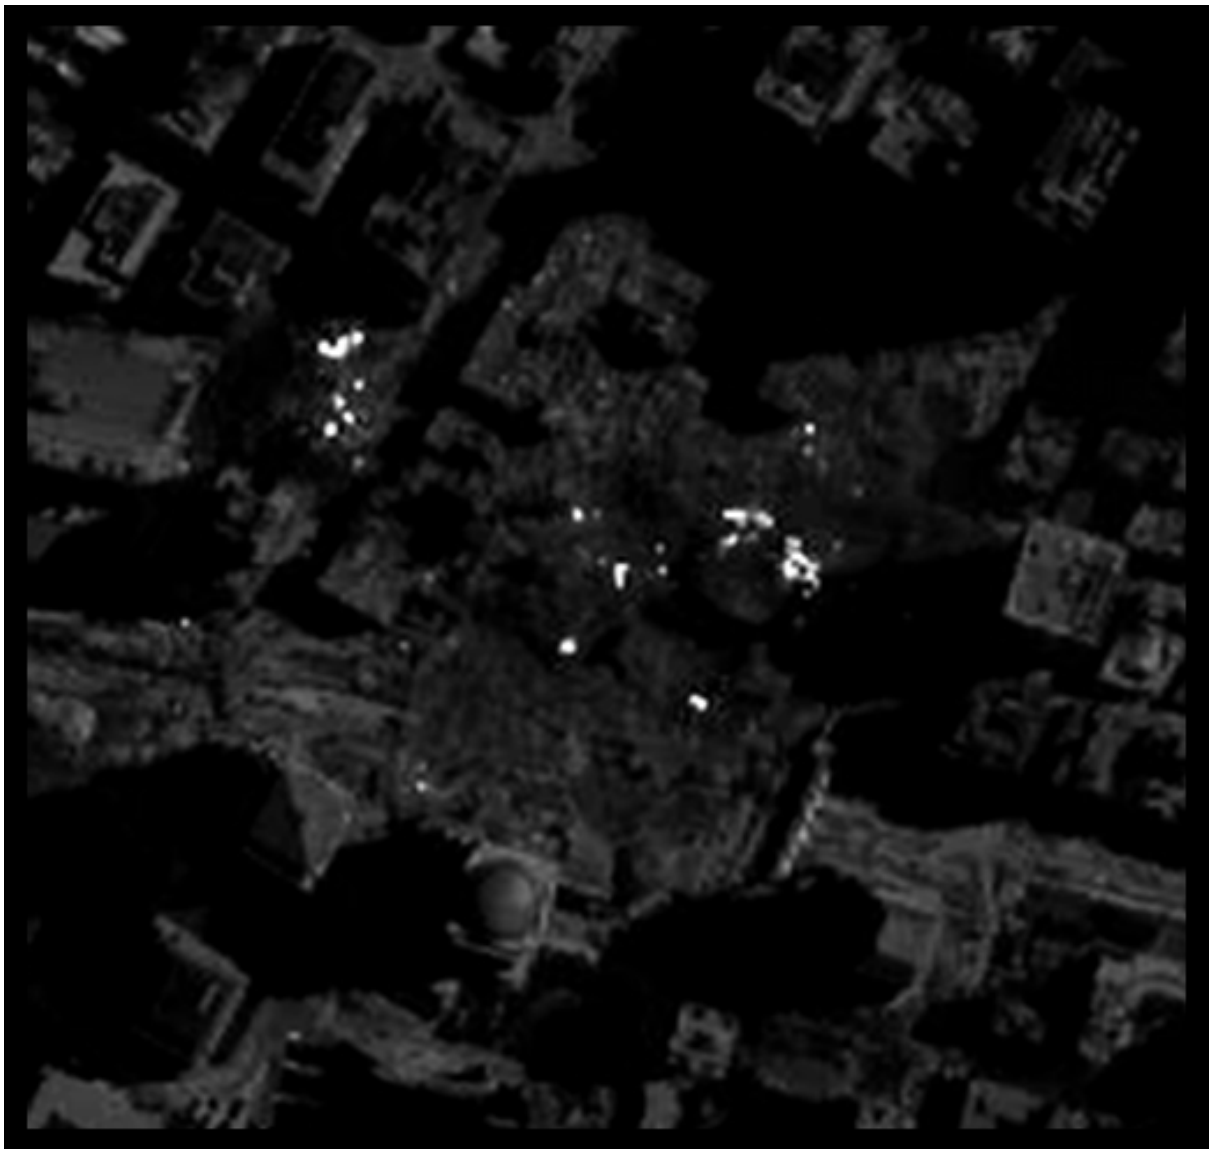
AVIRIS 2300-nm wavelength image of the World Trade Center disaster site acquired on the 16th of September 2001. nasa.gov
Additional thermal images from 09/16/01:
http://www.newyork.earthdata.com/images/thermal_sept162001_800.gif
http://s3.amazonaws.com/nasathermalimages/public/images/lq-map-therm1_800px.jpg loc.gov

As part of the World Trade Center disaster response, the NASA Airborne Visible/Infrared Imaging Spectrometer (**AVIRIS**) was flown over the site on the 16th and 18th of September 2001. AVIRIS measures the solar reflected spectrum from 370 to 2500-nm at 10-nm sampling. For this flight the data were acquired at 1.5-m spatial sampling with image coverage of the entire disaster site. AVIRIS measurements are spectrally, radiometrically, spatially calibrated in the laboratory and validated in flight. Rapid examination of the World Trade Center AVIRIS data in the 2300 nm spectral region showed numerous high radiance targets indicative of burning fires. A new spectroscopic algorithm was implemented to simultaneously solve for the temperature and fractional area of the fires. This algorithm uses the Planck function in conjunction with the full spectral shape measured by AVIRIS to determine the temperature and fractional area of the fire. This spectral algorithm overcomes the ambiguity between temperature and area that exists in single-spectral-band temperature estimation methods. With these AVIRIS data set and new algorithm, 8 hot spot zones were identified in the September 16th data with temperatures ranging from 700K to 1019K and fractional areas from 1.1 to 18%. Analysis of the data set acquired on September 18th showed 7 of the hot spot zones still present with temperatures ranging from 471K to 952K and fractional areas from 0.5 to 36%. These imaging spectrometer derived physical parameters of fire temperature and fractional-area were found useful to the personnel making decisions on the ground. The complete set measurements, analyses, and results of this effort are reported in this paper. cosis.net

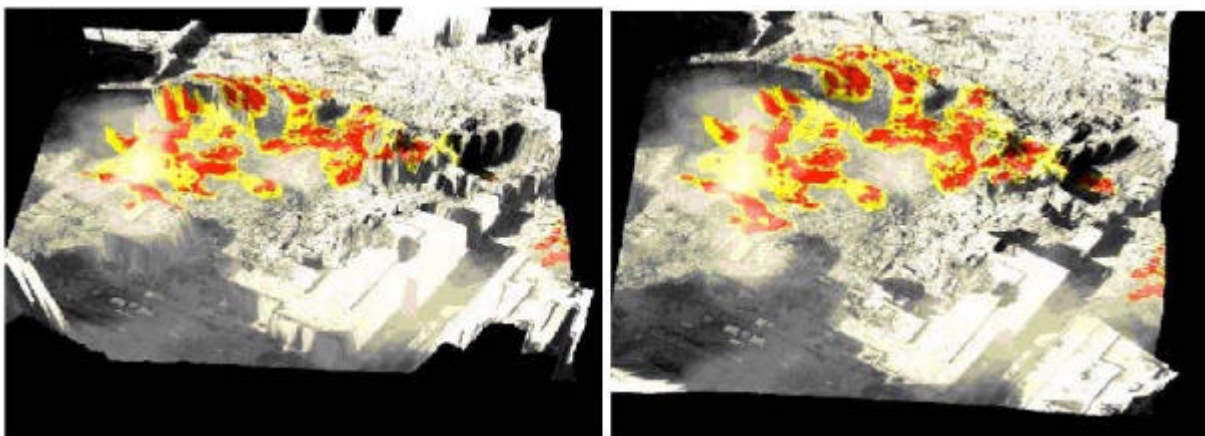
VRML visualization of Ground Zero from several perspectives, with orthophotography and thermal data draped over a LIDAR 3D terrain model. Datasets were acquired by EarthData on September 17th. esri.com
([additional thermal image from 09/17/01](#))

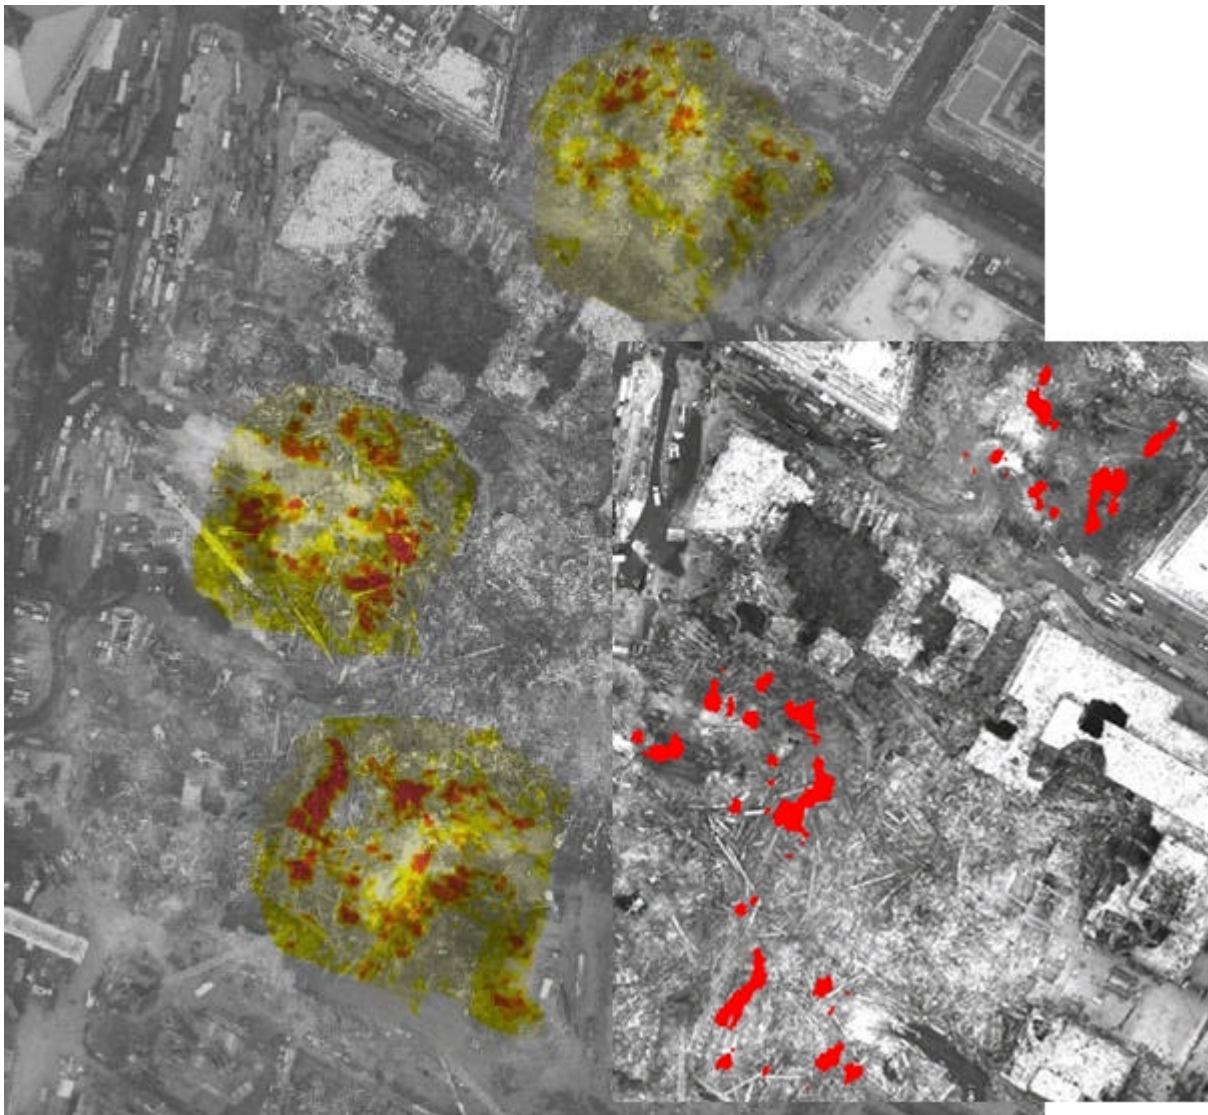
Thermal image of Ground Zero acquired by EarthData on October 7th using a Raytheon airborne sensor. The data are overlaid on an orthophotograph obtained on October 8th. Variations in temperature are evident across the site. However, these values were acquired (and are therefore displayed) using an 8-bit radiometric scale, rather than an absolute calibration such as degrees Fahrenheit. ([source](#))

Sensor: [Raytheon Nightsight](#)
([inset_source](#))

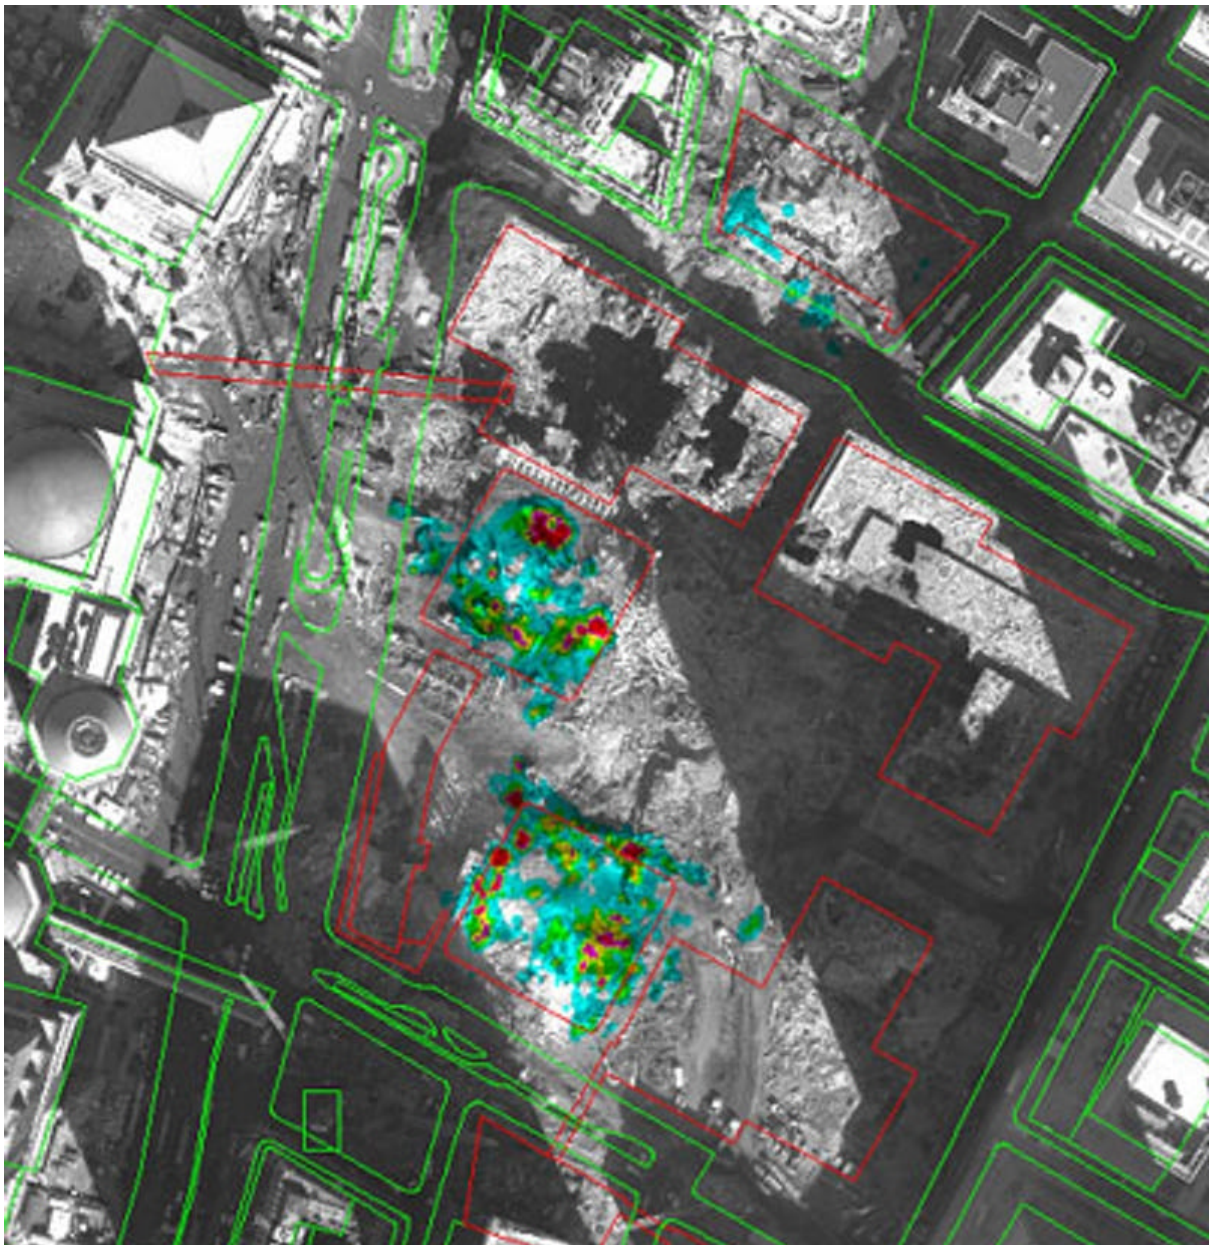
WTC – Thermal Imagery, October 18, 2001. New York State, Office for Technology (c2001) and EarthData International. loc.gov

Absolute Temperature (^oF)

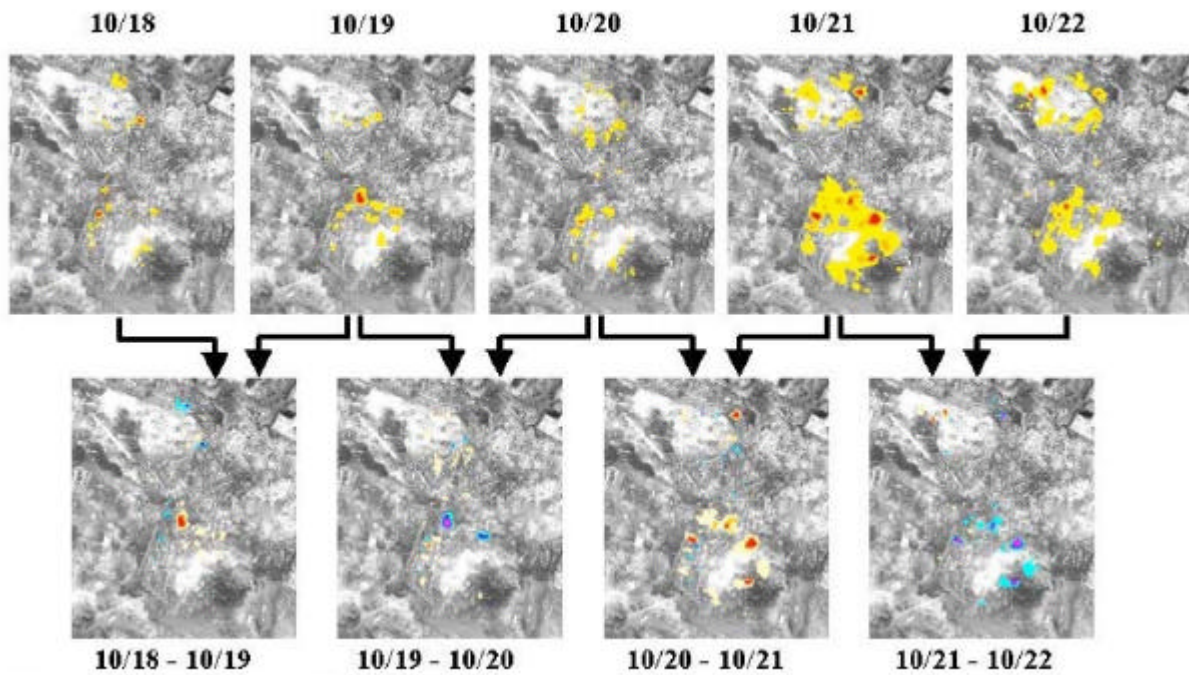
**Change in Temperature (^oF)**

The sequence of temperature readings on the top row of were acquired by EarthData between 18th-22nd October, using the FLIR thermal imaging device. They are overlaid here with the aerial orthophotography from October 7th. Notably, the thermal data are calibrated to record temperature in degrees Fahrenheit, thereby addressing the limitations of relative magnitudes acquired using the Raytheon sensor. The red areas correspond with temperatures exceeding 125F and the yellow class equates with temperatures from 75F to 125F . Values < 75oF are omitted.

Sensor: [FLIR ThermaCAM SC2000 \(esri.com\)](http://esri.com)

An overlay of the above image from 09-18-01 with the [corresponding AVIRIS image from 09-18-01](http://s3.amazonaws.com/nasathermalimages/public/images/09-18-01_FLIR_overlay_with_09-18-01_AVIRIS_and_visible_background_from_10-07-01.xcf) is available in [gimp\(xcf\)](http://s3.amazonaws.com/nasathermalimages/public/images/09-18-01_FLIR_overlay_with_09-18-01_AVIRIS_and_visible_background_from_10-07-01.xcf) format here: http://s3.amazonaws.com/nasathermalimages/public/images/09-18-01_FLIR_overlay_with_09-18-01_AVIRIS_and_visible_background_from_10-07-01.xcf

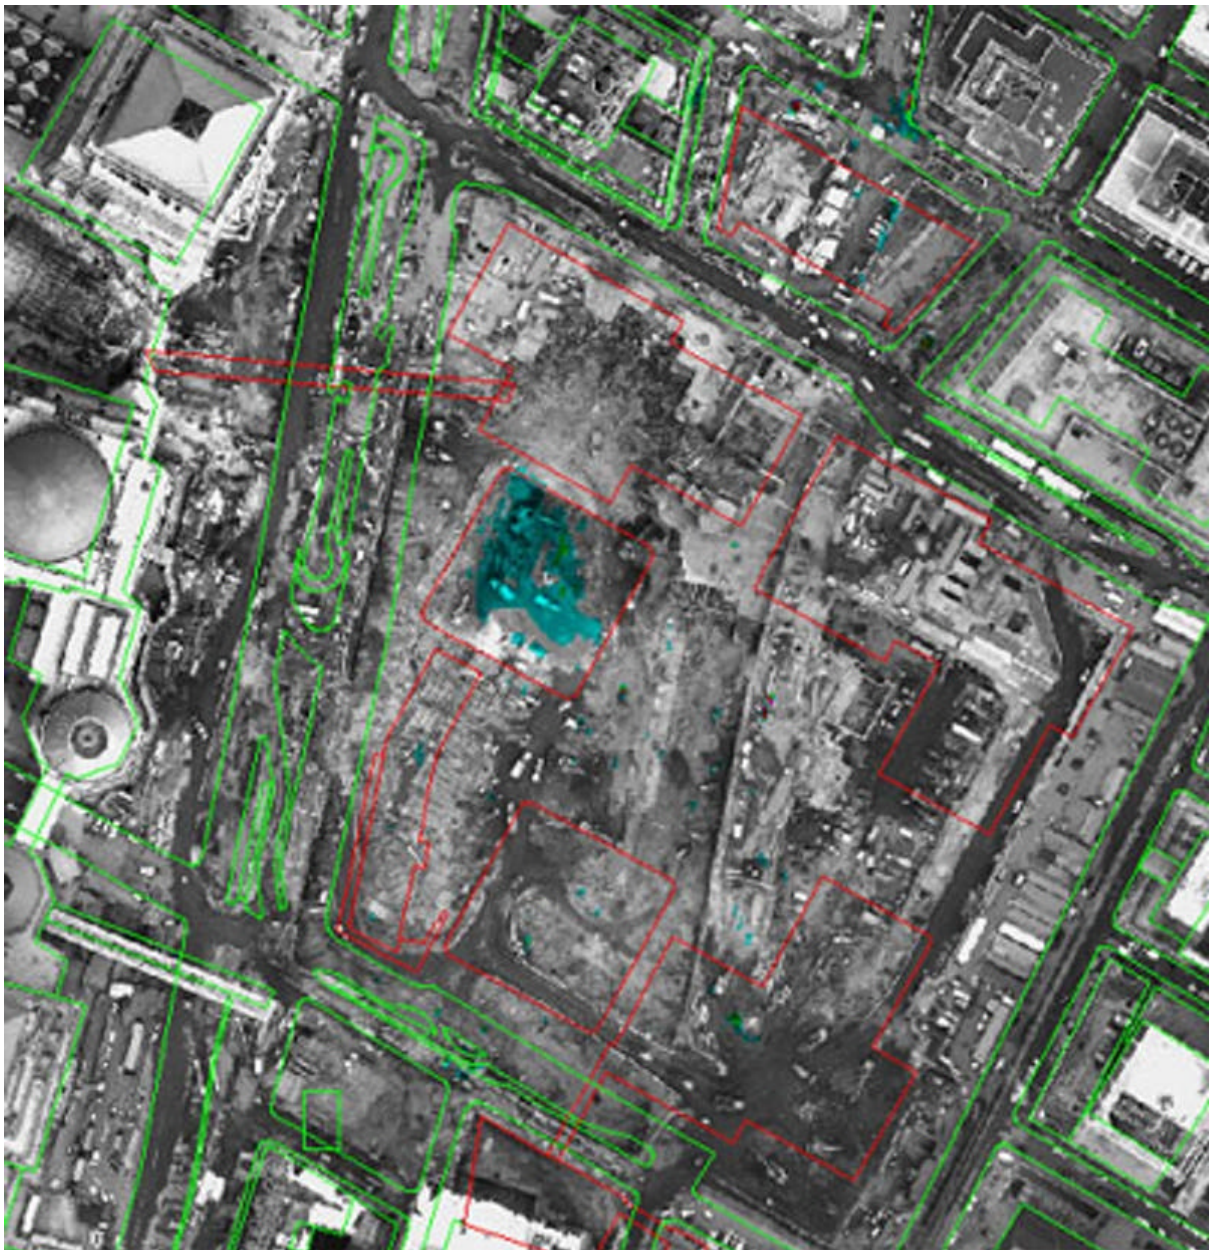
WTC – Thermal Imagery, February 12, 2002. New York State, Office for Technology (c2001) and EarthData International. [loc.gov](#)
[\(source\)](#)

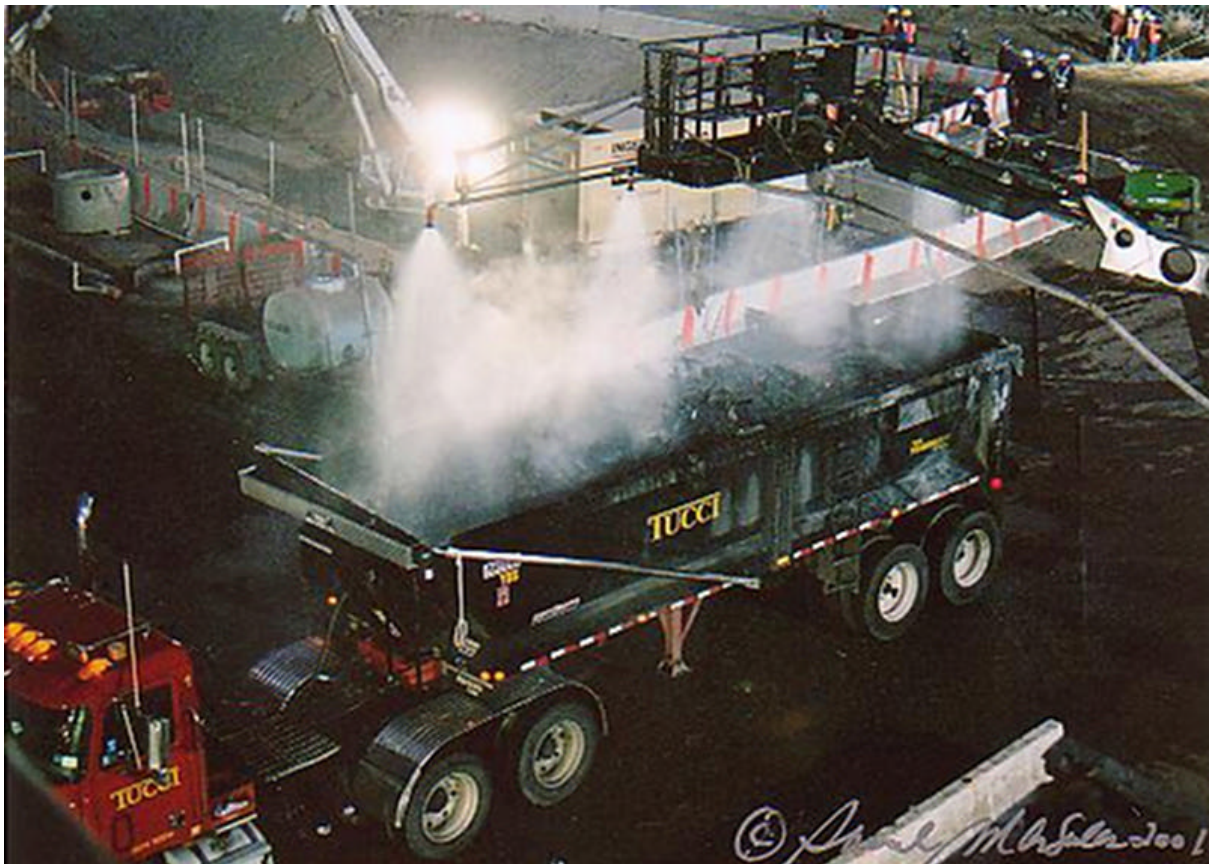
These sprayers were also used to cool the high temperature debris before it left the site. Several trucks were returned to the site for additional cooling because the law enforcement officers would not let them through the tunnels leaving Manhattan until they stopped steaming. libertypost.org/army.mil

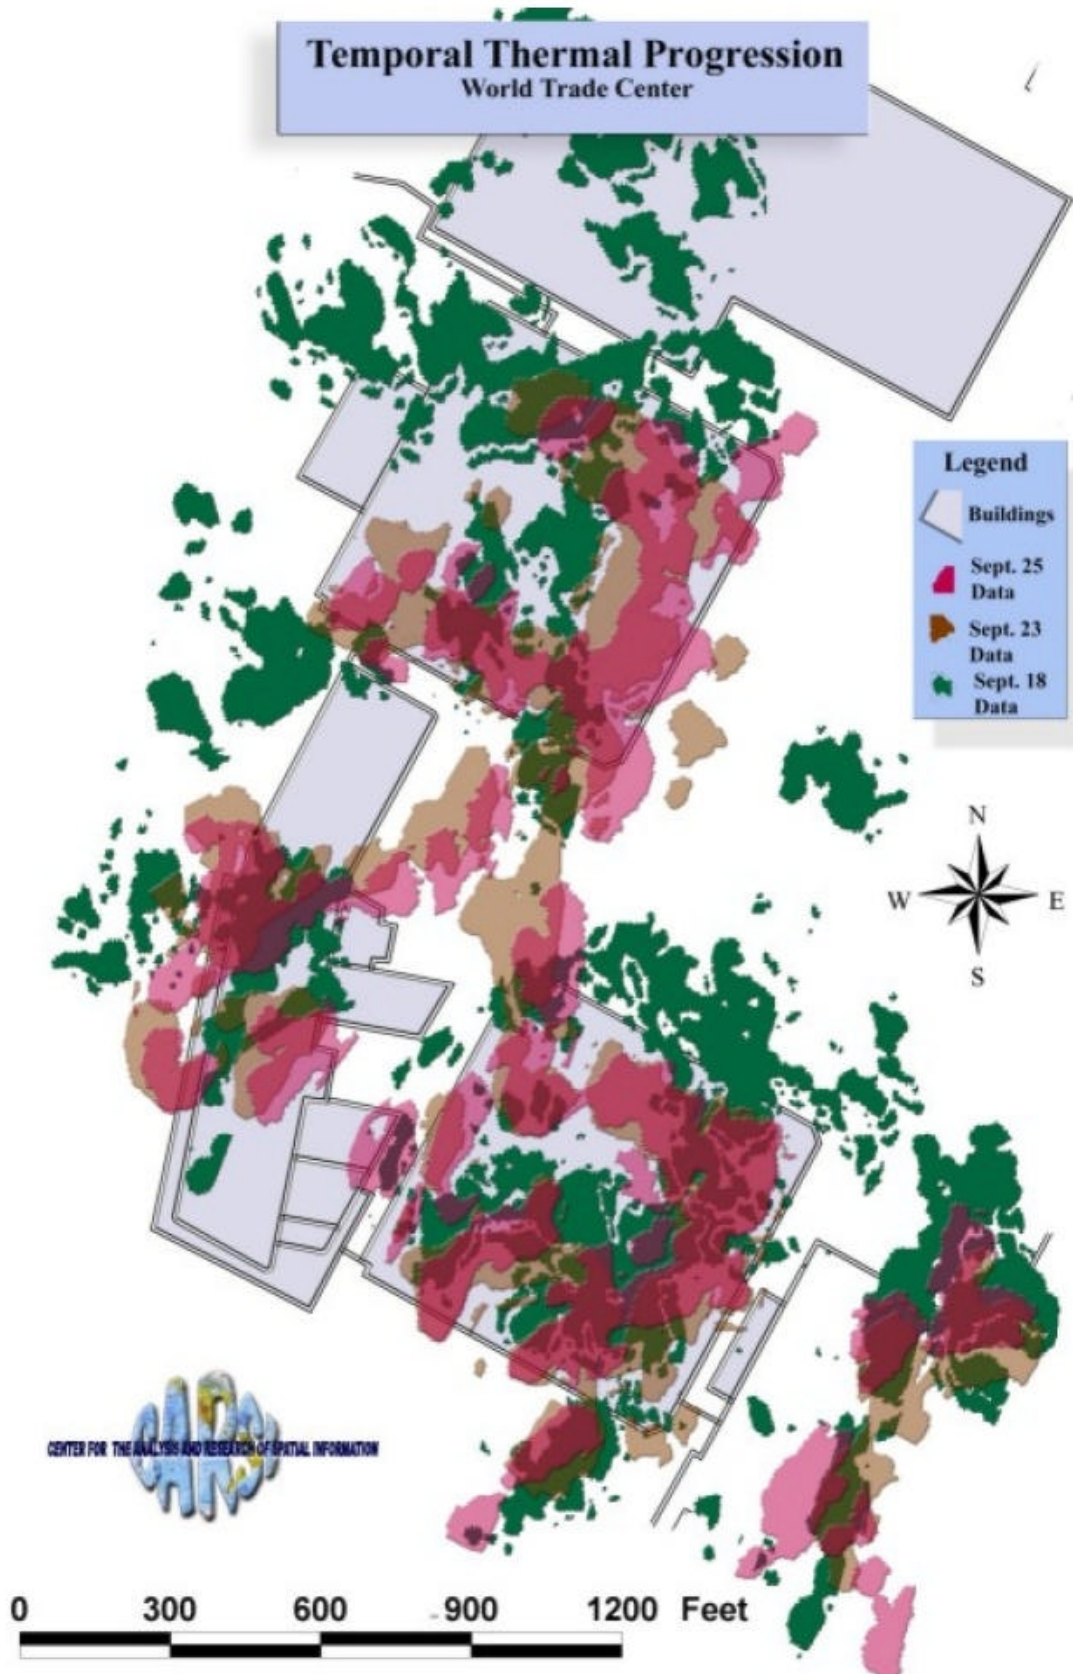
Thermal Imagery of the progression of molten steel hotspots from September 18 to September 25. Notice how the heat becomes concentrated towards the center from the fringe areas. The threshold between color ranges was 1/2 of the energy, so that in a range of 0-255, everything above 127.5 was kept (0-127.5) and everything below was ignored. -Maddalena Romano cuny.edu ([source2](#))

September 16—Thermal imagery measures the progression of underground heat on about a weekly

basis. These images are produced in 8-bit grayscale, with brightness levels of 0-255, 0 being the hottest and expressed as pure white. This is known as emissive data, or heat being given off from the structure from underlying hot debris or molten steel. Smoldering is yet undetectable, because potential fires appear cold until they are exposed to air. The first thermal images produced began on September 16, and are repeated on two day intervals. I would like to thank Jeff Bliss for the wonderful information and imagery he provided for this story, and acknowledge the 16-20 hours days CARSI Lab director Dr. Sean Ahearn has been putting in at the OEM. I would also like to credit Jeff Bliss, Constandinos Theophilides, and Bob Sklar for their tireless analysis. For a more in-depth look on CARSI, see the upcoming January special issue. cuny.edu
